The long-term behaviour of viaducts subjected to heavy traffic and situated in an aggressive environment: the viaduct on the Polcevera in Genoa

R. MORANDI

A REINFORCED CONCRETE VIADUCT SERVING A SPEEDWAY IN NORTHERN ITALY.

THE VIADUCT ON THE POLCEVERA, FOR THE GENOA-SAVONA SPEEDWAY.

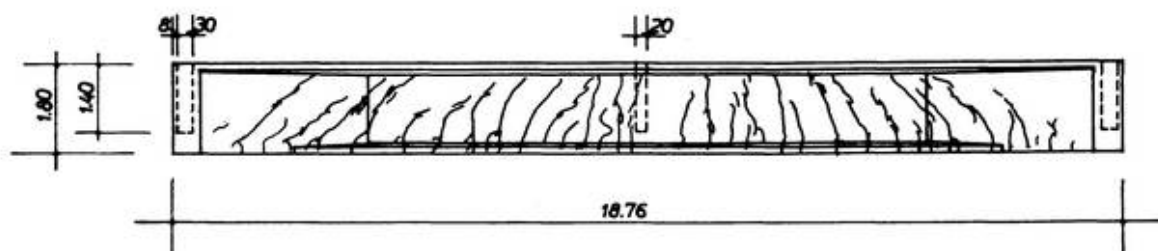
Fig. 2 - Crack pattern on the external rib of bay No. 21

As for the crack width, we can briefly conclude that the inclined cracks near the bearings of the deck reached the maximum width of 0.5 mm, while the width of all the others were between the 0.05 and 0.3 mm, with most of them being less than 0.2 mm.

Finally, the behaviour of the structures under the dynamic impulses shows a satisfactory level of integrity of the entire assembly. Obviously, after having considered all the above results, we reached the conclusion that it was sufficient to apply coats of various substances (elastomers) on the external surfaces in order to prevent the reinforcements to be reached and damaged by air through the cracks.
